REPORT ON USATECOM PROJECT NO. 8-3-0030-06F  
PRODUCT IMPROVEMENT TEST OF BOLT ASSIST DEVICES  
FOR RIFLE, CALIBER .223, AR15  
REPORT NO. DPS-1120  
NOVEMBER 1963

U. S. ARMY  
DEVELOPMENT AND PROOF SERVICES

Three models of charging handle bolt assist devices for the caliber .223 AR15 rifle were evaluated for effectiveness in manual extraction and bolt closure operations. A plunger-type bolt closure device was also evaluated. The devices were tested for operation under various adverse conditions, and other special tests were also conducted. Only the plunger-type bolt closing device provided an effective means for closing the bolt under adverse conditions. The modified charging handle did not provide adequate means for extraction operations under adverse conditions. It is recommended that the charging handle bolt assist device tested not be adopted.

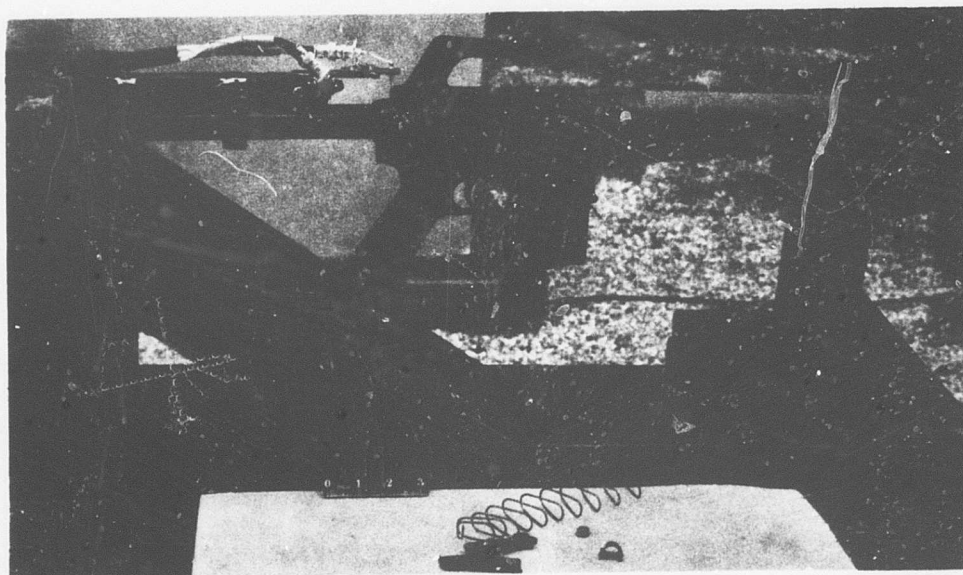
**Figure 9: Standard AR15 Rifle (008271) Subjected to Cook-Off.**

2.5.3 Discussion. Cook-off did not cause the charging handle to disengage from the receiver and move rearward in either the standard or the modified AR15 rifle.

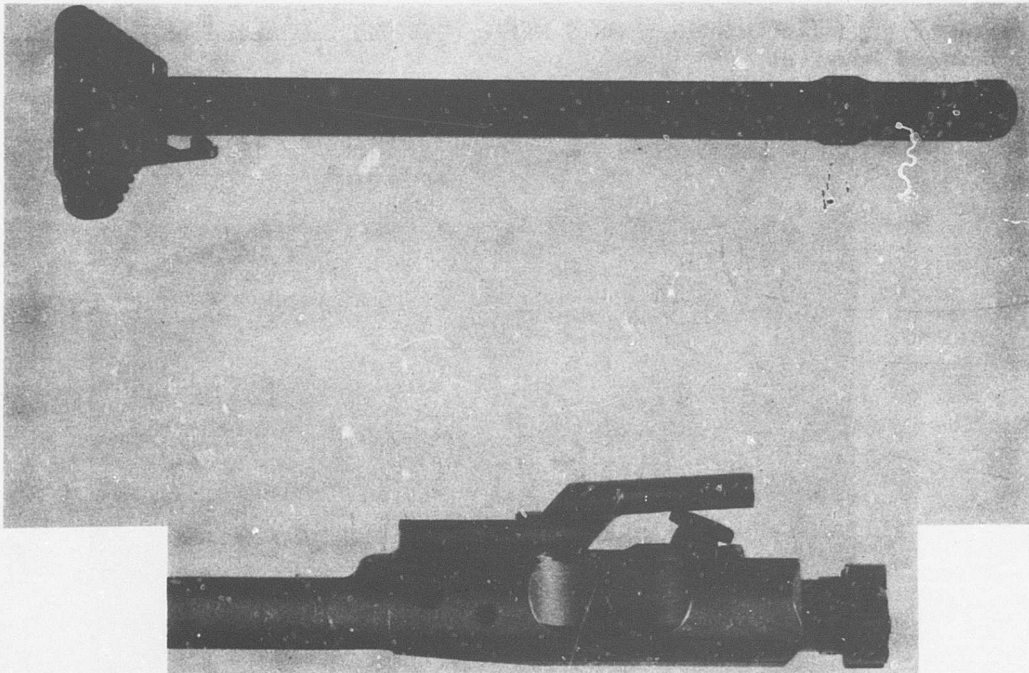
The standard AR15 rifle upper receiver did not crack in the area below the carrying handle. All the components of the magazine except the tube were blown downward and free of the rifle. No rounds were stored in the magazine at the time of the cook-off. Figures 9, 10, and 11 show the over-all view of the rifle, the damaged bolt and undamaged charging handle, and damaged receiver, respectively.

Figure 10: Damaged Bolt and Undamaged Charging Handle from Standard AR15 Rifle (008271) Subjected to Cook-Off.
